United States General Accounting Office

October 1997

DEFENSE INVENTORY

Management of Surplus Usable Aircraft Parts Can Be Improved

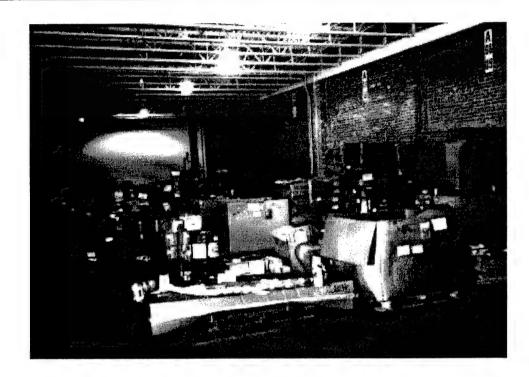
Figure 2: Cobra Helicopter Parts Stored at Corpus Christi DRMO

At the Corpus Christi DRMO, we observed quantities of 157 different usable parts for the AH-1 Cobra helicopter scheduled for destruction (see fig. 2). Specifically, we noted that there was a total of 1,972 usable, mostly new, helicopter parts in a DRMO warehouse. The parts originally cost \$6.9 million. According to the DRMO Chief, these parts were to be destroyed beginning May 3, 1997, to free up storage space. We contacted the Defense Reutilization and Marketing Service and advised it of our concern with the scheduled destruction because the assigned demilitarization codes indicated no military technology was associated with 155 of the 157 different parts and because there were sufficient amounts of warehouse storage space for the parts.

Defense Reutilization and Marketing Service officials said that in February 1996, they placed a prohibition against selling Cobra parts at DRMOS because the Army-assigned demilitarization codes were inaccurate. The property disposal specialist responsible for the prohibition said the Army planned to review and validate the demilitarization codes for the Cobra helicopter parts and he wanted to be sure the codes were accurate before proceeding with a sale or destruction action. He said the Army had not completed its demilitarization code review. The specialist said he also instructed the DRMOS to destroy the parts if they started experiencing a storage impact. After a meeting with the Chief of the Corpus Christi DRMO, the Defense Reutilization and Marketing Service issued a memorandum directing the DRMOS not to destroy any Cobra parts unless they are in a scrap condition and to hold usable parts in storage until the Army completes the demilitarization code review.

Army Aviation and Troop Command officials who are responsible for reviewing and validating demilitarization codes for Cobra helicopter parts told us they were waiting to complete the demilitarization code review until after Army headquarters makes a decision on whether or not to sell disarmed, surplus Cobra helicopters to the public for use in such purposes as fighting forest fires. In our opinion, accurate code assignments are required regardless of whether the helicopters are sold to the public.

- Require the Army to complete its validation of the demilitarization codes assigned to Cobra helicopter parts so commercial-type parts and nonsignificant military unique parts can be sold.

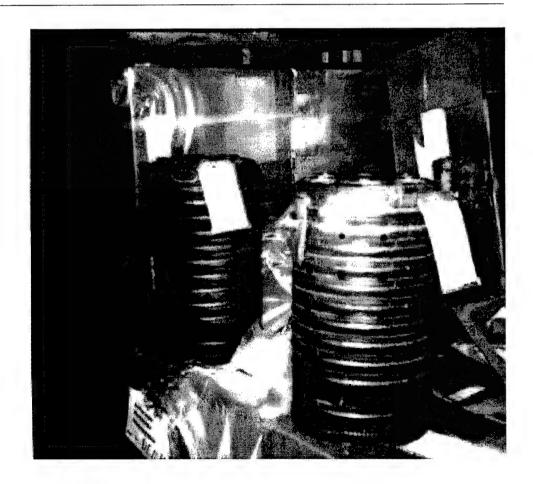
Figure II.1: Engine Combustion Chamber

Parts Assigned Inaccurate Demilitarization Codes The Air Force decided that 184 TF-33 engine combustion chambers (Stock No. 2840008285214RV) (see fig. II.1) used on the KC-135 aircraft were surplus and sent them to the Oklahoma City DRMO. The parts originally cost \$452,352. On April 15, 1997, the DRMO destroyed the 184 parts, although the parts were repairable. The DRMO destroyed the parts because the Air Force had assigned a demilitarization code to the parts requiring total destruction to protect military technology. The DRMO estimated that it spent \$211 to destroy the parts and sold them as scrap for \$3,450. After we pointed out that this was a commercial-type item, the Air Force equipment specialist said the assigned demilitarization code was incorrect because the parts contained no military technology. As a result, the DRMO destroyed parts that the private sector could have used. The equipment specialist corrected the demilitarization code.

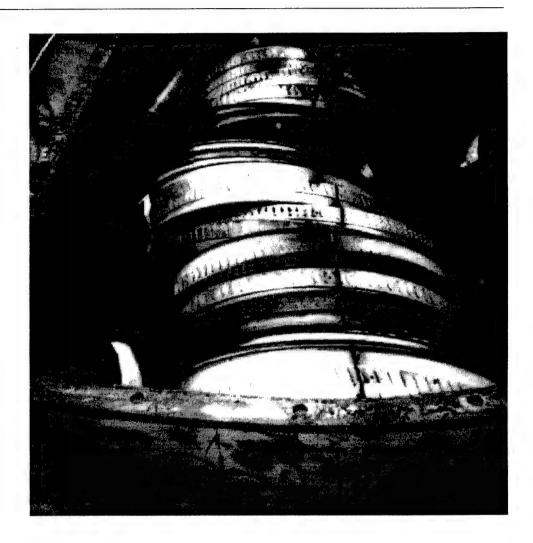
Figure II.2: Nozzle Rings

On April 9, 1997, we observed the destruction with a cutting torch of 20 nozzle rings (Stock No. 2840011611133RV) (see fig. II.2) used on the KC-135 aircraft engine. These parts originally cost \$94,400. The Oklahoma City DRMO destroyed the parts because the Air Force had assigned a demilitarization code that required total destruction to protect military technology. According to the equipment specialist, the Air Force replaced the parts with a newer version. He said that the parts sent to the DRMO, although usable, were no longer needed by the Air Force. After we pointed out that this was a commercial-type item, the equipment specialist said the assigned demilitarization code was incorrect because the part contained no military technology. He also said the destroyed parts were usable on commercial Boeing 707 aircraft in the private sector. As a result, the DRMO destroyed parts that the private sector could have purchased. The equipment specialist corrected the demilitarization code.

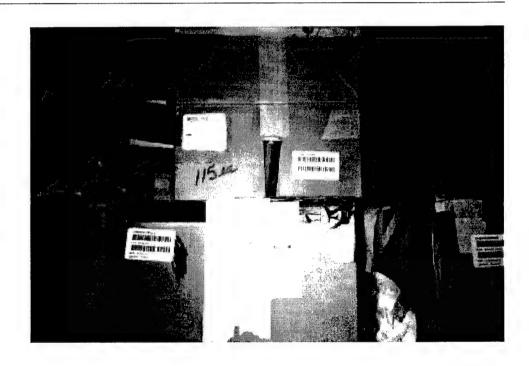
Figure II.3: Turbine Rotor Blades in Manufacturer's Original Packaging

helicopter for disposal. Since the Army had assigned demilitarization code F to the parts, indicating that they had flight safety implications, the DRMO requested disposition instructions from the Army Aviation and Troop Command. The Command instructed the DRMO to destroy the part unless it was (1) unused, (2) in serviceable condition, (3) physically marked with the manufacturer's code, and (4) in the manufacturer's original packaging. The DRMO decided that the parts met this exception and offered them for sale. DRMO records showed that the turbine rotor blades were sold in a lot with another turbine rotor blade for \$13,796.
